ANNUAL SITE INSPECTION REPORT

JULY 2000

BAILEY SUPERFUND SITE

ERNEST J. SCHROEDER
ENGINEERING CONSULTANTS, INC.

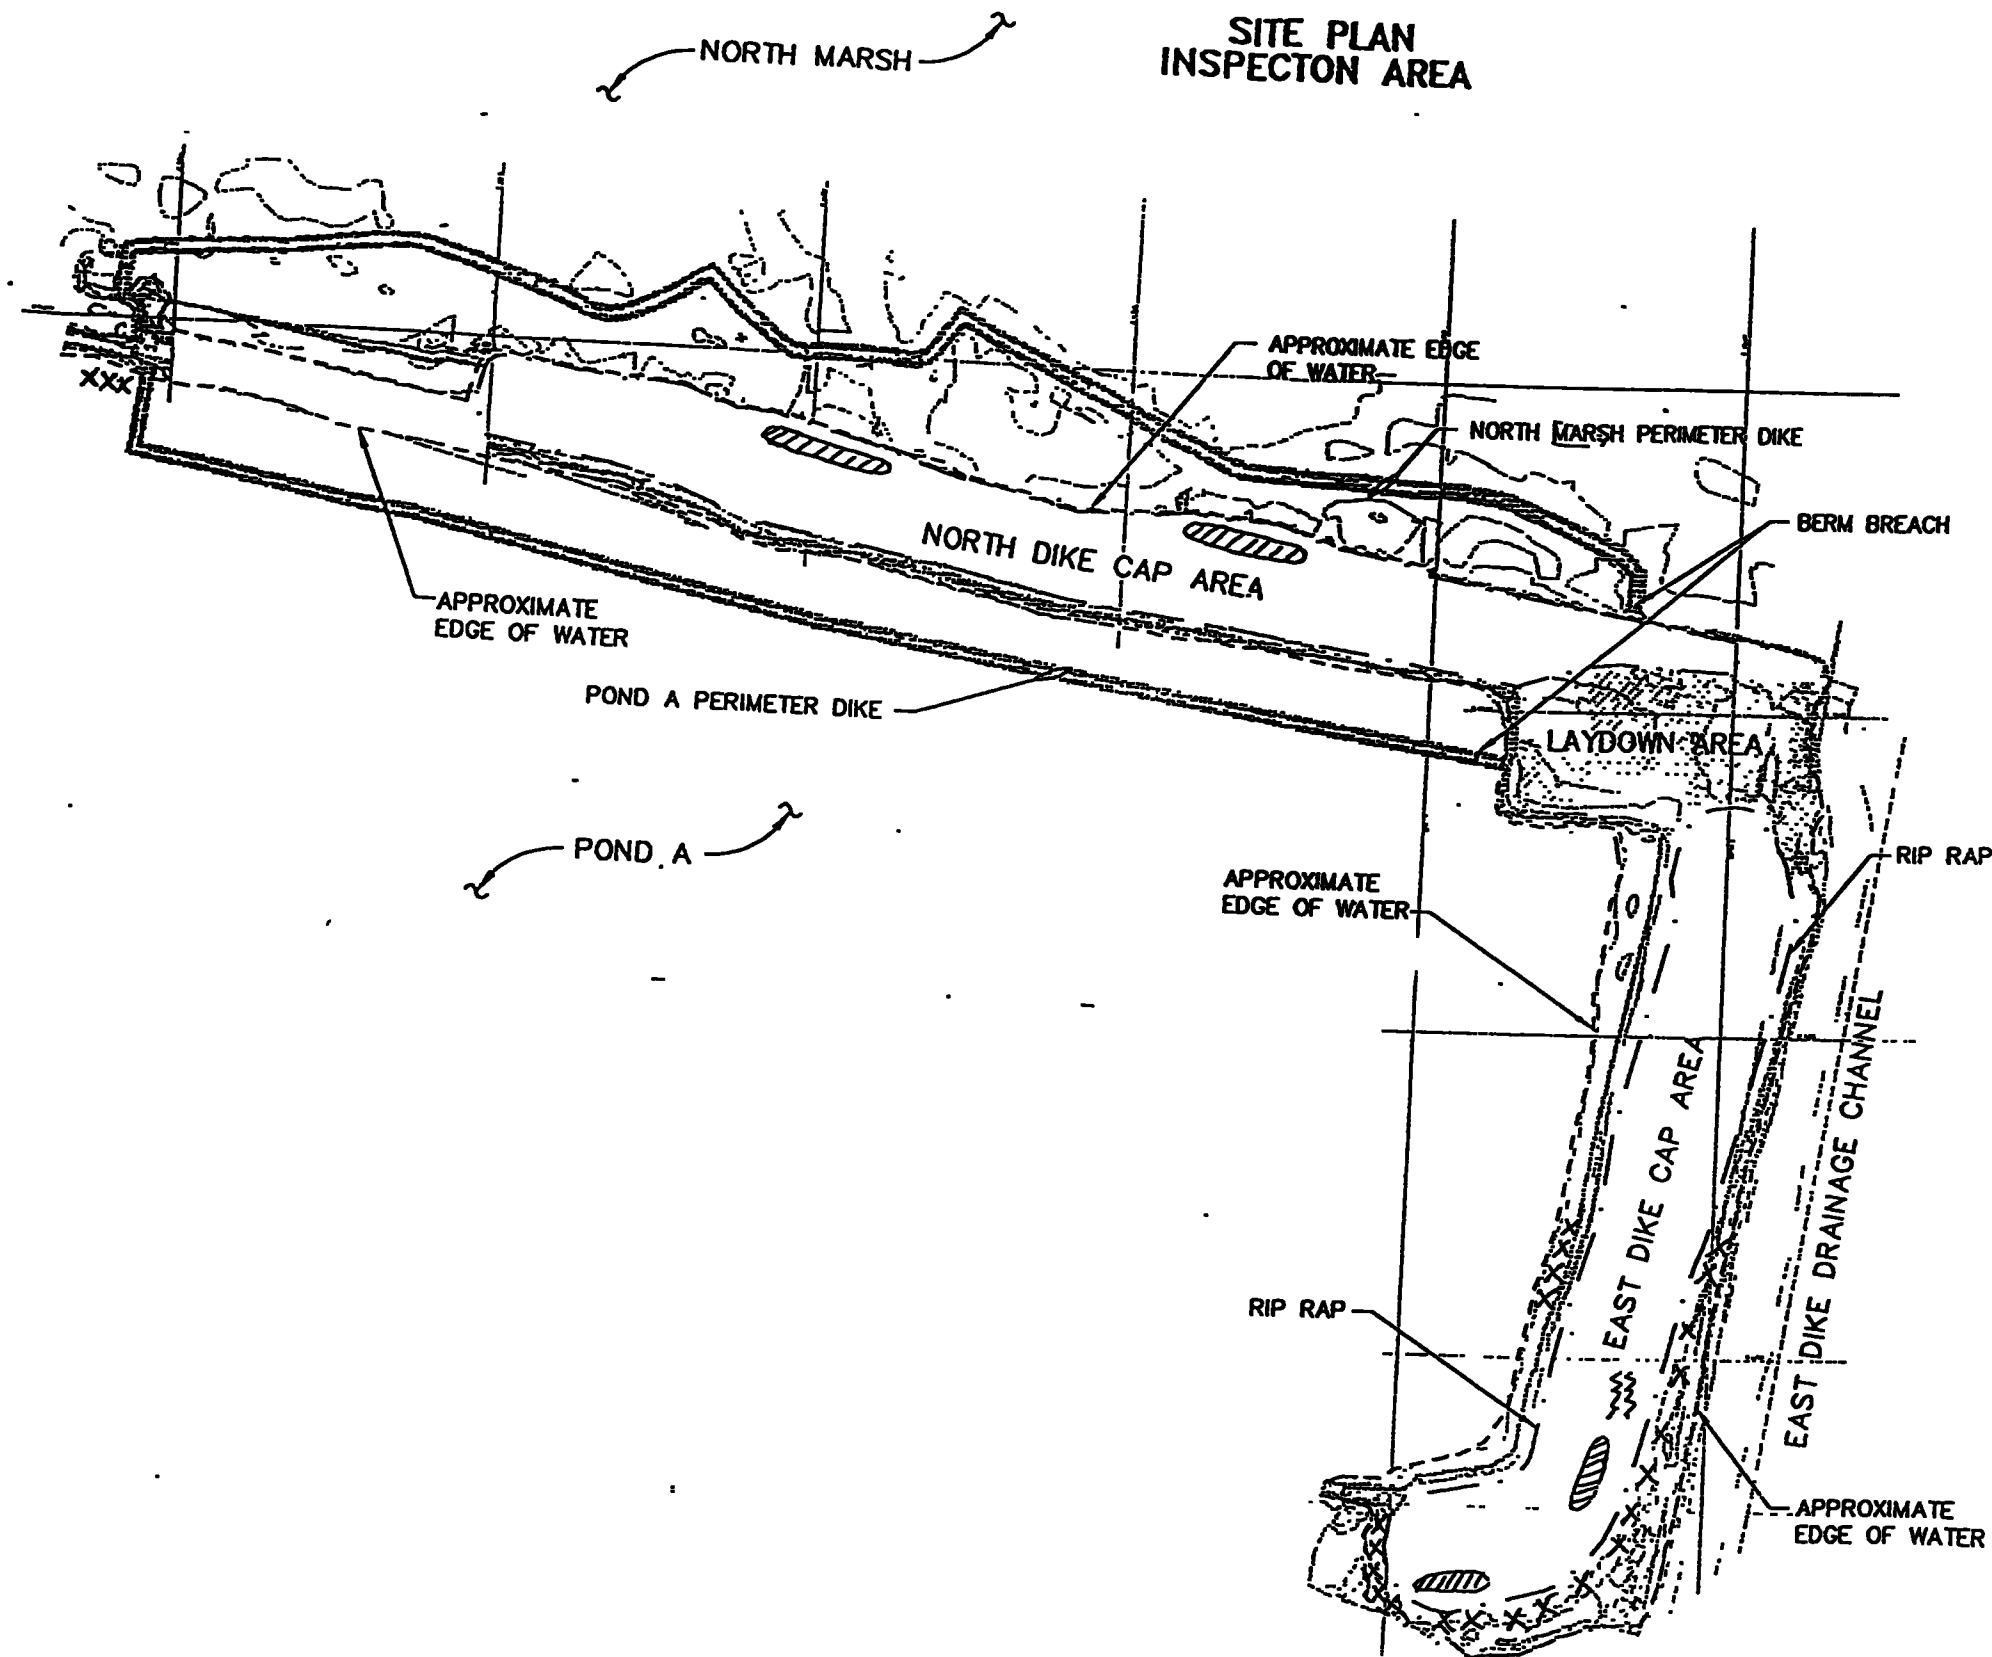
SITE MAP

The landfill caps were inspected for signs of erosion, exposure, differential settlement, and ponding. The condition of the surface vegetation and the gas vents were also noted. Areas of stressed vegetation are noted on the map in Appendix B. No grass needs to be re-seeded. Some woody plants are growing along the outer edge of both cap areas as illustrated on the map. These will be removed to prevent them from spreading onto the cap slopes and caps themselves. No erosion along the dike slopes and caps is evident. There are also some signs of minor soil desiccation on the East Dike Cap near the southern end (see map in Appendix B).

- 1) Vegetation/grass is stressed due to lack of rainfall. This is normal for Texas summers. No action needed.
- 2) Some signs of soil desiccation on eastern cap, as evidenced by "cracks".
- 3) Some woody plants are growing along outer edge of eastern cap (see map). These should be removed or mowed down to prevent them from growing on sides and top of cap.

- Stressed vegetation
- Soil desiccation evidenced on eastern cap
- Weedy plants growing along outer edge of eastern cap
- Chain and lock not properly installed for gate at SW corner of eastern cap.
- Road at NE corner at access bridge is slowly being eroded by stormwater

- Woody plants were noted growing along the edges of both caps. These plants will be removed to prevent further propagation;
- The chain and lock on the southern gate of East Dike Cap are not installed properly. The lock will be replaced with one identical to the main gate and the chain will be secured around both gateposts to prevent entrance. A verbal request to Rodney Townsend was made at the time of the inspection to complete this task and a written request was made in September 2000; and
